NBSIR 81-2191 (DoE)

The Use of the Slow Strain Rate Technique for the Evaluation of Structural Materials for Application in High-Temperature Gaseous Environments

Final Report

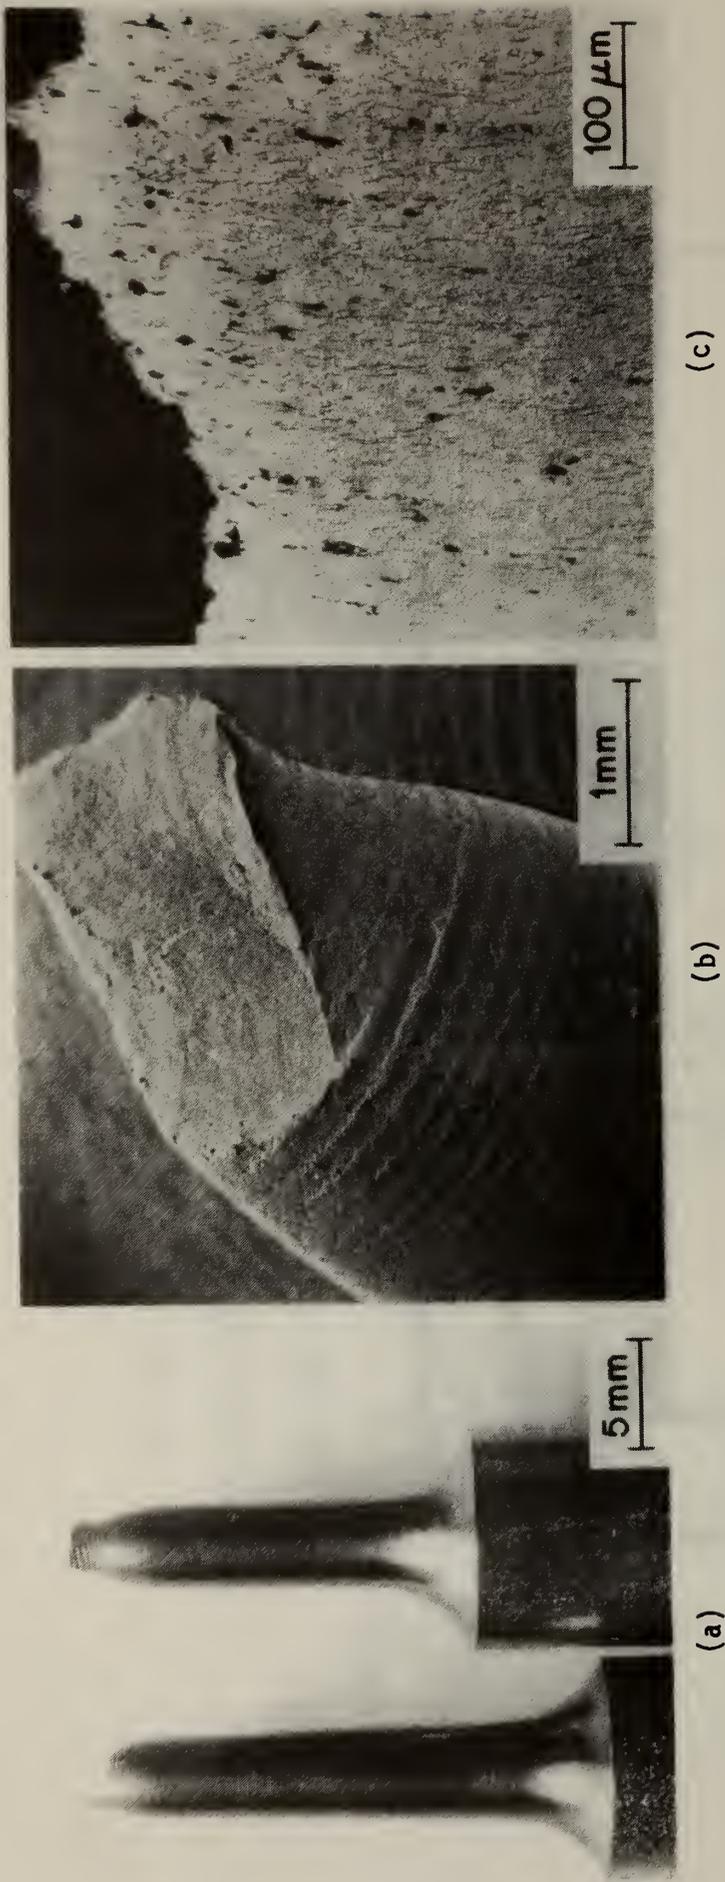
UTS — 568 MPa (82,300 psi)
 Elongation — 18.8%
 RA — 65.2%

Fig. 30. Type 347 stainless steel tested in He at 450 °C at a strain rate of 1×10^{-6} /s. (a) Photomicrograph of the fractured specimen. (b) Scanning electron micrograph at the region of fracture. (c) Photomicrograph of the sectioned specimen near the fracture.

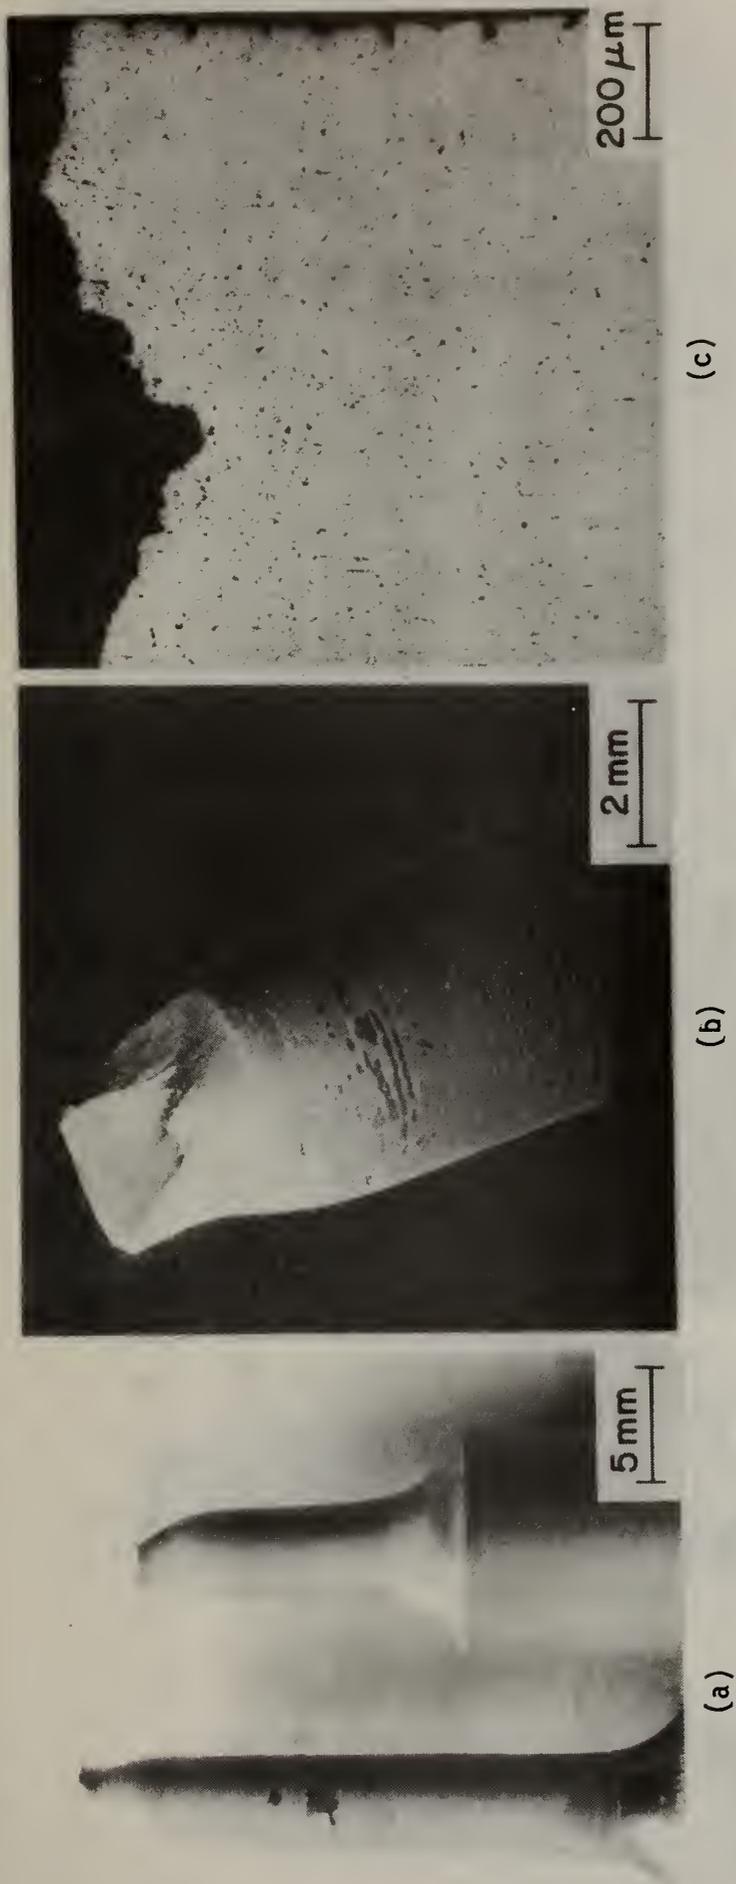
UTS — 591 MPa (85,700 psi)
 Elongation — 17.0%
 RA — 60.2%

Fig. 31. Type 347 stainless steel tested in the oxidizing-sulfidizing environment at 450 °C at a strain rate of 1×10^{-6} /s. (a) Photograph of the fractured specimen. (b) Scanning electron micrograph at the region of fracture. (c) Photomicrograph of the sectioned specimen near the fracture.

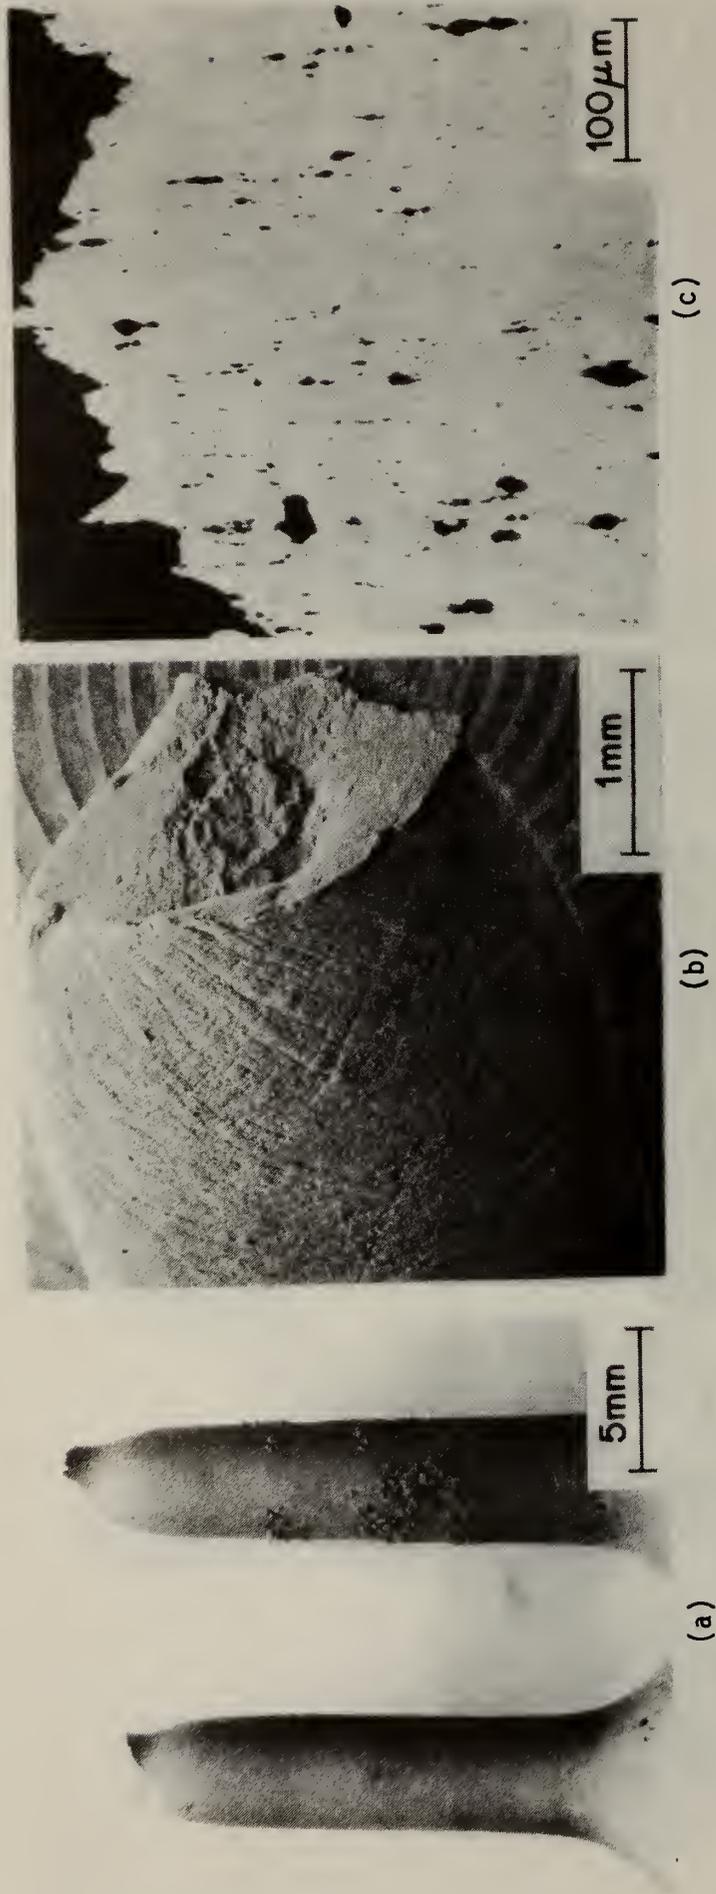
UTS — 590 MPa (85,500 psi)
 Elongation — 18.4%
 RA — 59.7%

Fig. 32. Type 347 stainless steel tested in the oxidizing-sulfidizing-carburizing environment at a strain rate of 1×10^{-6} /s.
 (a) Photomicrograph of the fractured specimen.
 (b) Scanning electron micrograph at the region of fracture.
 (c) Photomicrograph of the sectioned specimen near the fracture.

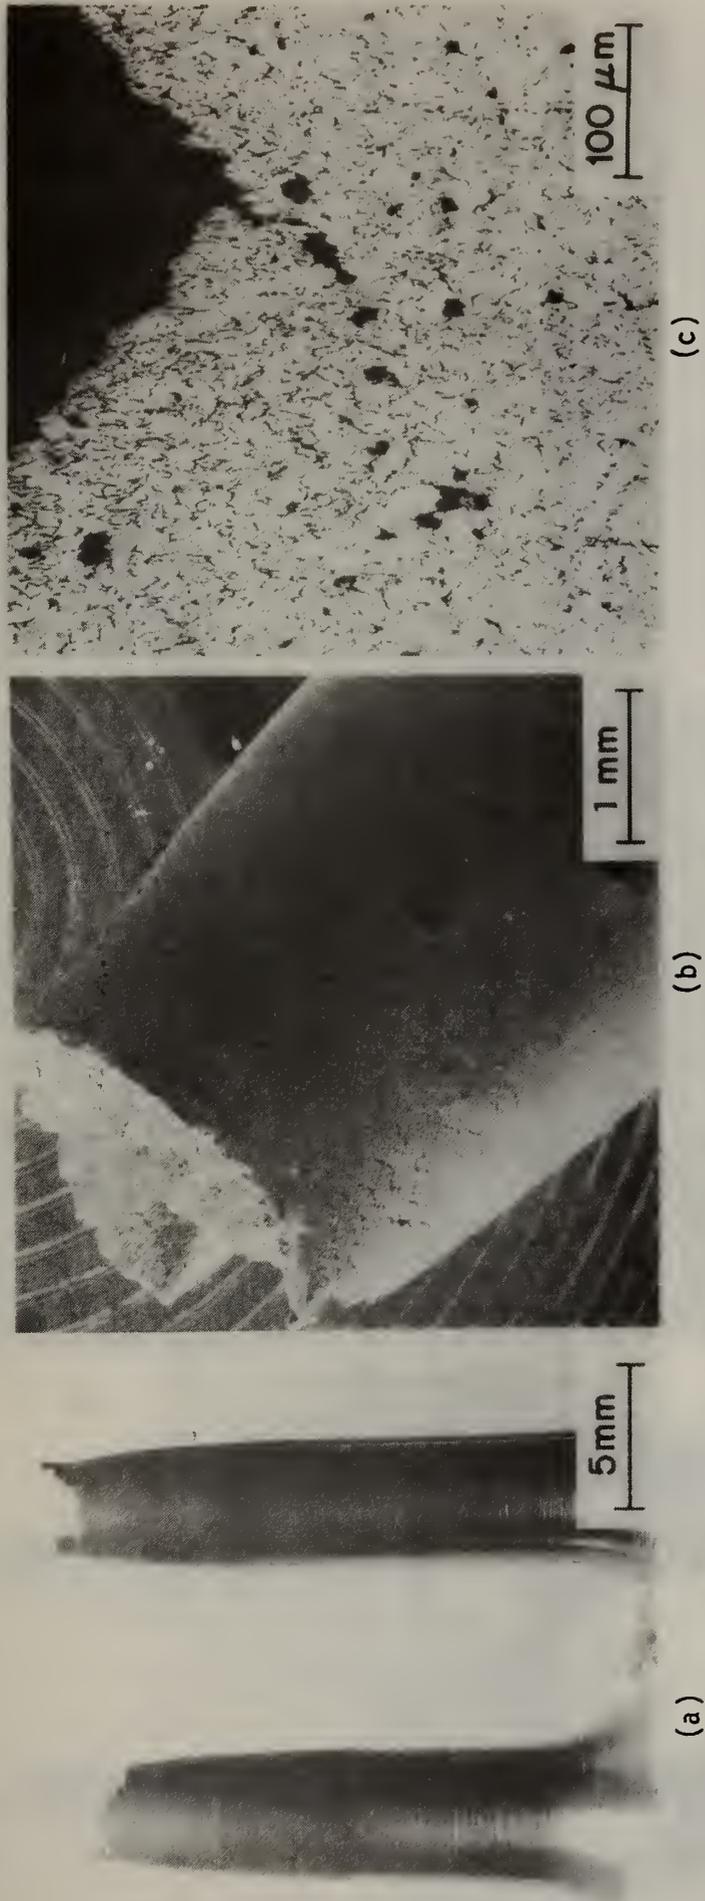
UTS — 451 MPa (65,300 psi)
 Elongation — 13.4%
 RA — 52.2%

Fig. 33. Type 347 stainless steel tested in He at 600 °C at a strain rate of 1×10^{-6} /s. (a) Photomicrograph of the fractured specimen. (b) Scanning electron micrograph at the region of fracture. (c) Photomicrograph of the sectioned specimen near the fracture.

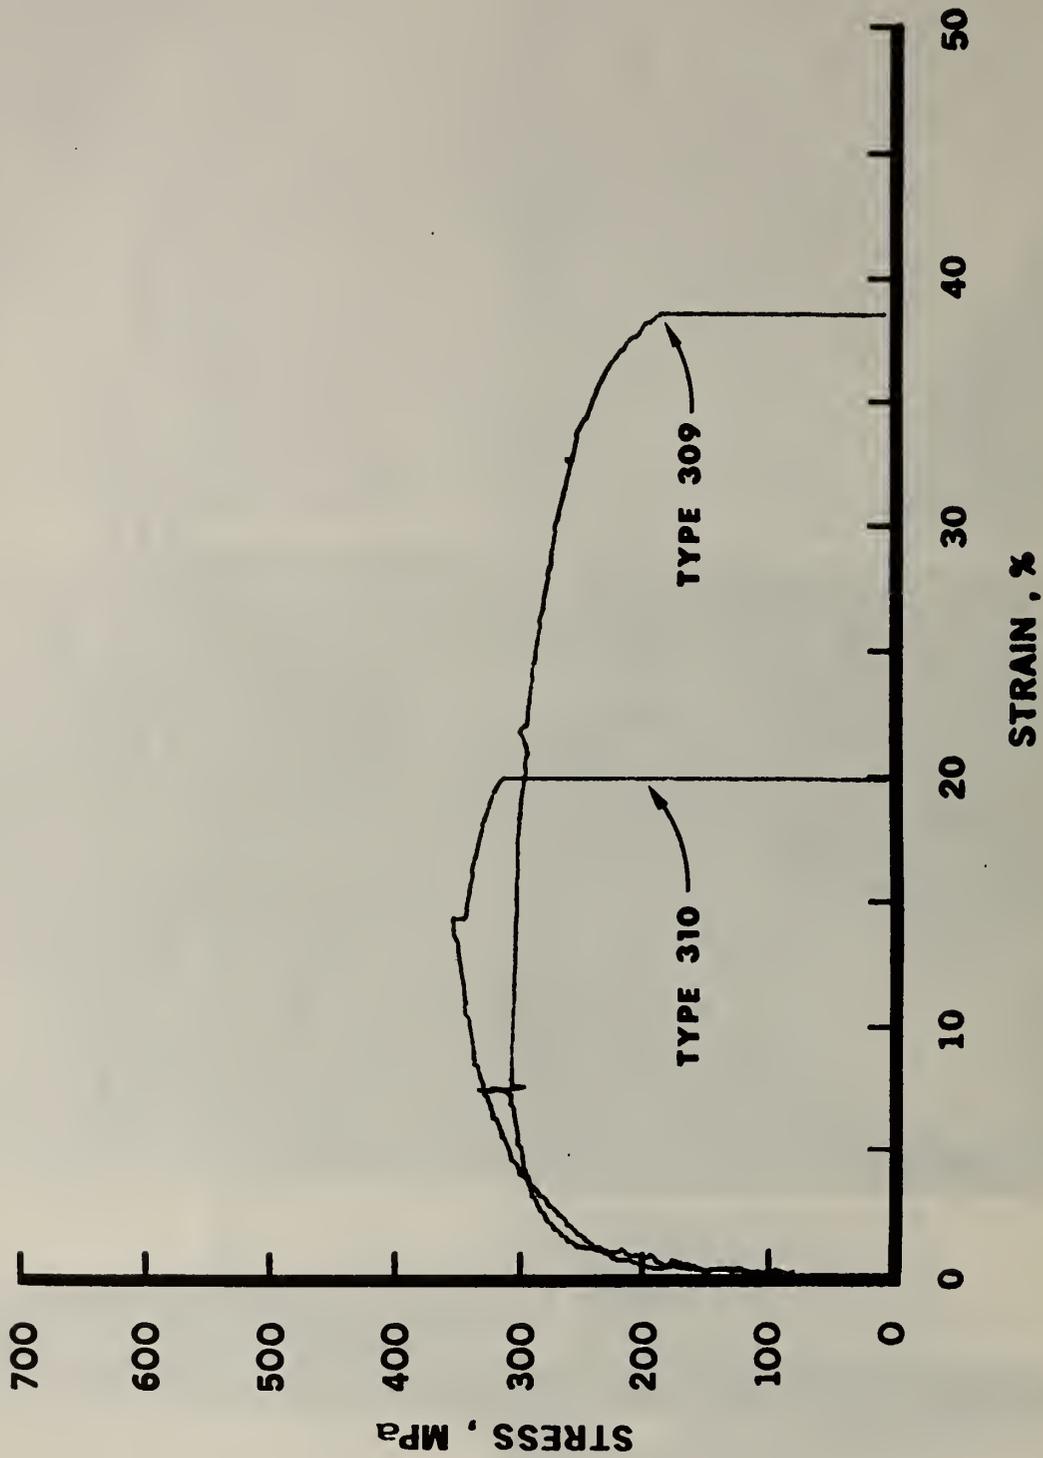
Fig. 36. Comparison stress-strain curves of Types 309 and 310 specimens tested at a strain rate of 10^{-6} /s in He at 600 °C.

Type 309: Limited tests were carried out on this alloy, which is similar in composition to Type 310 except for its lower Ni and Cr contents and higher Si content, Table 1. The Type 309 specimens were tested at 600°C(1100°F), in various environments and at several strain rates and the results were compared to those for Type 310 tested under similar conditions. Stress-strain curves for both alloys tested at a strain rate of 10^{-6} /s in He are shown in Fig. 36. The ductility of Type 309 is far greater, see also Table 6, and this correlates with the small amount of surface cracking observed in this alloy, Fig. 37, compared to that in Type 310, Fig. 17. The cracking in Type 309 is shallow and is confined to the necked region; no well defined rim of intergranular fracture could be detected at the main fracture, in contrast to the case of Type 310. Similar shallow secondary cracking was observed in tests on Type 309 specimens at 600°C(1100°F) in Ar and the oxidizing/sulfidizing/ carburizing atmosphere; the tensile parameters for these atmospheres are given in Table 6.

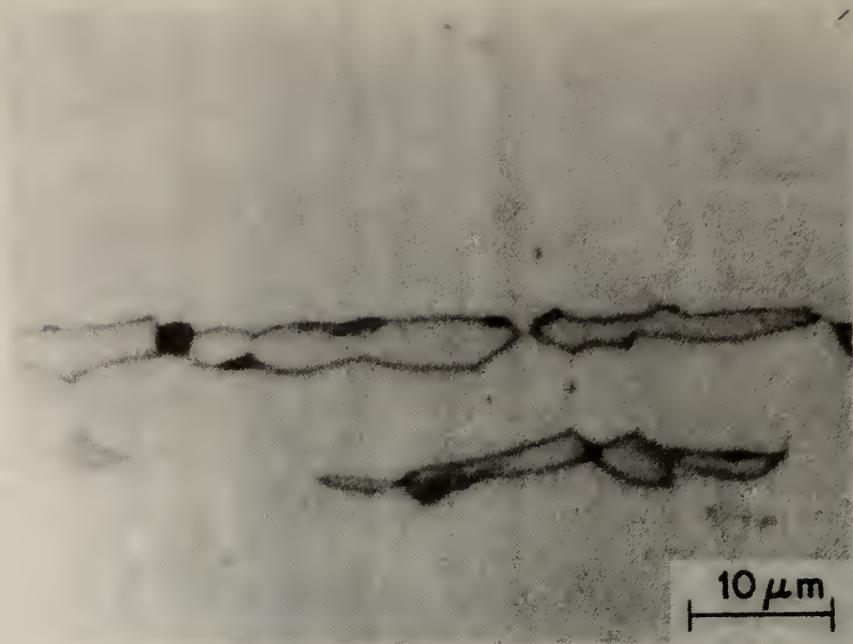
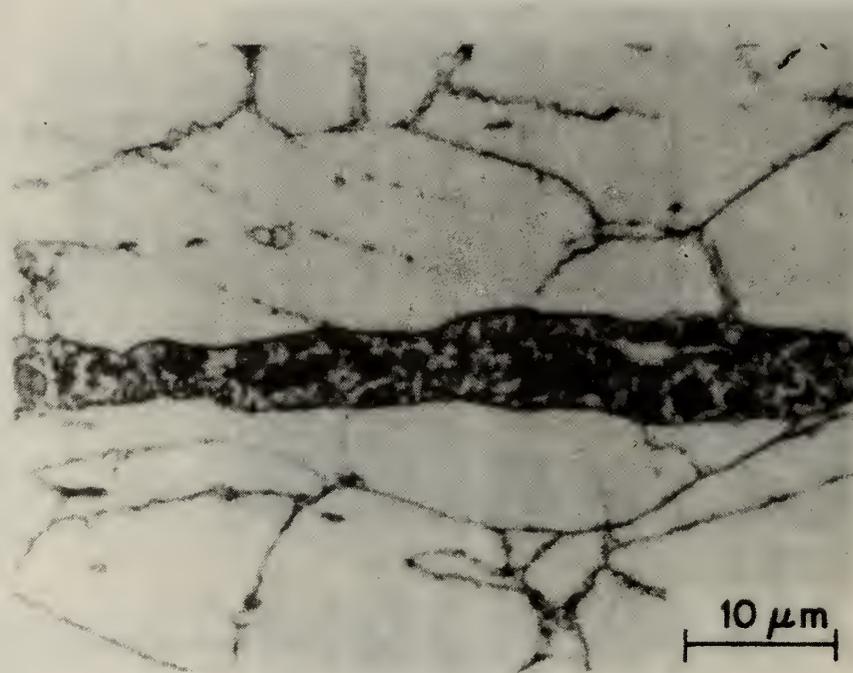
Fig. 38. Microstructure of Type 309 stainless steel. (a) Islands of ferrite in austenite matrix, as-received condition. (b) Islands of ferrite transformed to mixed ferrite and carbides, which were identified by chemical etchants, after being tested at 600 °C in He at a strain rate of 10^{-6} /s.

The microstructure of the Type 309 steel was found to contain ferrite, in which carbides were precipitated during testing at 600°C(1100°F), Fig. 38. There was no evidence for the formation of sigma phase, which is known to be formed from ferrite during long times at high temperatures. The presence of the ferrite may account for the greater resistance of Type 309 to intergranular cracking in our tests, but its specific role was not determined.

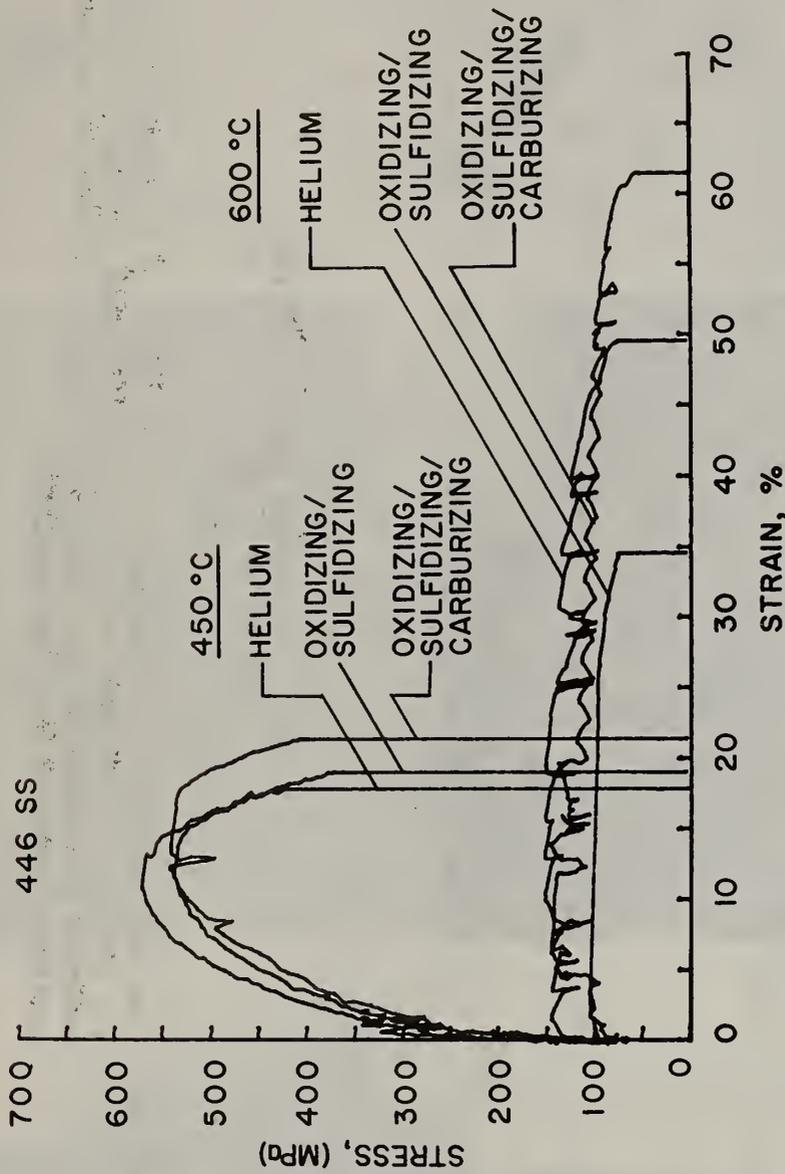
Fig. 39. Stress-strain curves for Type 446 specimens tested at 450 °C (840 °F) and 600 °C (1100 °F) in He and in oxidizing/sulfidizing and oxidizing/sulfidizing/carburizing coal gasification environments at a strain rate of 1×10^{-6} /s.

Tests were carried out on Type 446 steel, selected because of its resistance to corrosion and oxidation at high temperatures. Tests were carried out at 450°C(840°F) and 600°C(1100°F) in ultra-pure tank He and in the simulated coal gasification environments, i.e., oxidizing/sulfidizing and oxidizing/sulfidizing/carburizing, using a strain rate of 10⁻⁶/s. The resulting stress-strain curves are shown in Fig. 39. The data for 450°C(840°F) were not significantly different for the three environments, despite the fact that shallow surface cracks were visible within the necked region of specimens tested in the coal gasification environments, Figs. 41 and 42, but not in the He test, Fig. 40. The nature of the shallow cracks, i.e., inter- or transgranular, was not determined. At 600°C(1100°F), UTS values were significantly lower than at 450°C(840°F) in all test environments, and the elongation and RA were higher, Figs. 39 and 43-45. The mechanical properties can be seen to be significantly lower for the coal gasification environments compared to the specimen tested in He. Surface cracking was visible in the necked region in the three environments, Figs. 43-45, but the morphology was different in the coal gasification cases, the cracks adopting a mosaic pattern. Despite the apparent environmental effect, the overall failure was ductile in each case, as evidenced by the large values of elongation and RA. Moreover, the question of whether environmental reactions occur at this temperature is academic, since it is clear from a comparison of the UTS values at 450°C(840°F) and 600°C(1100°F) that the latter is above the temperature at which this alloy should be used under stress.

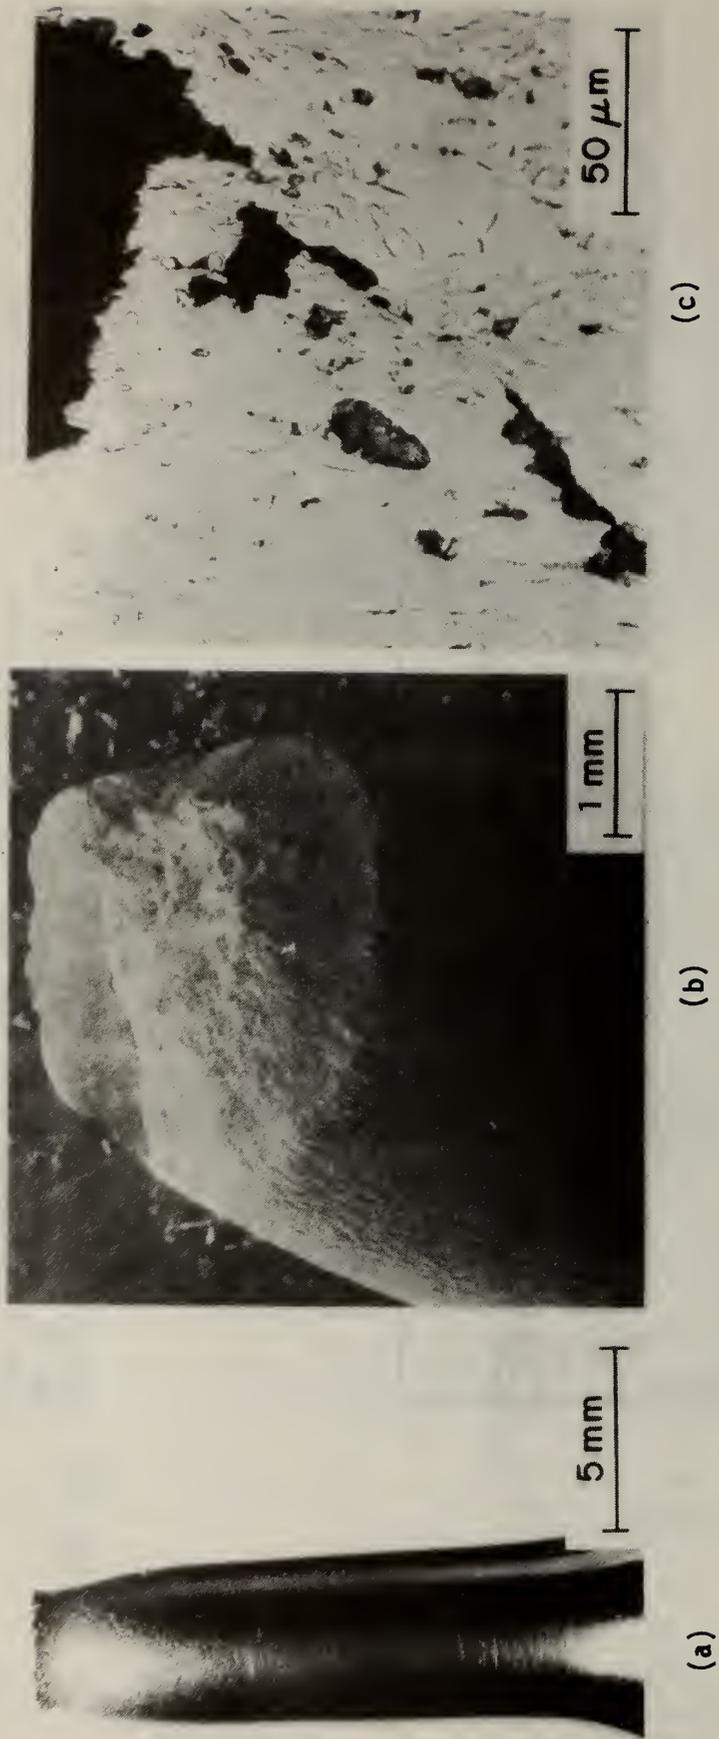
UTS — 586 MPa (85,000 psi)
 Elongation — 17.3%
 RA — 57.0%

Fig. 40. Type 446 stainless steel tested in He at 450 °C at a strain rate of 1 X 10⁻⁶/s. (a) Photograph of the fractured specimen. (b) Scanning electron micrograph at the region of fracture. (c) Photomicrograph of the sectioned specimen near the fracture.

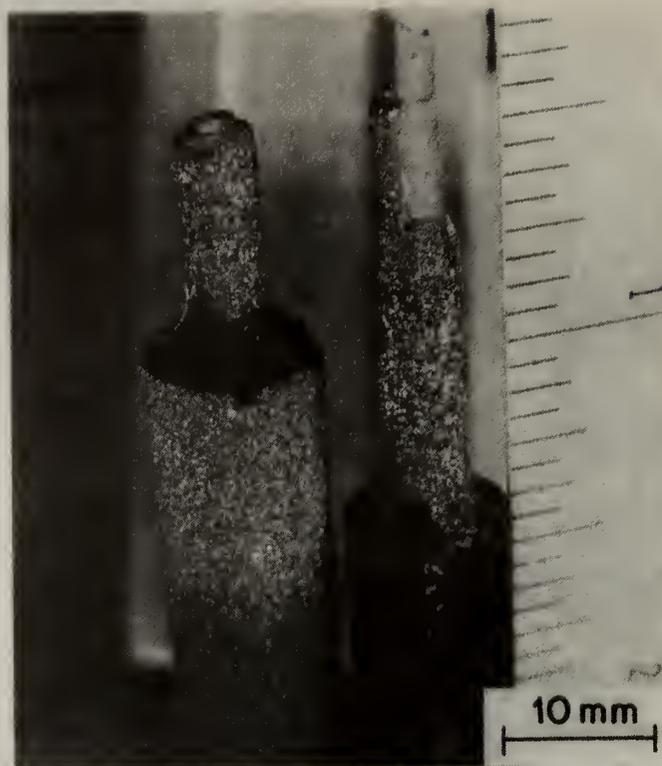
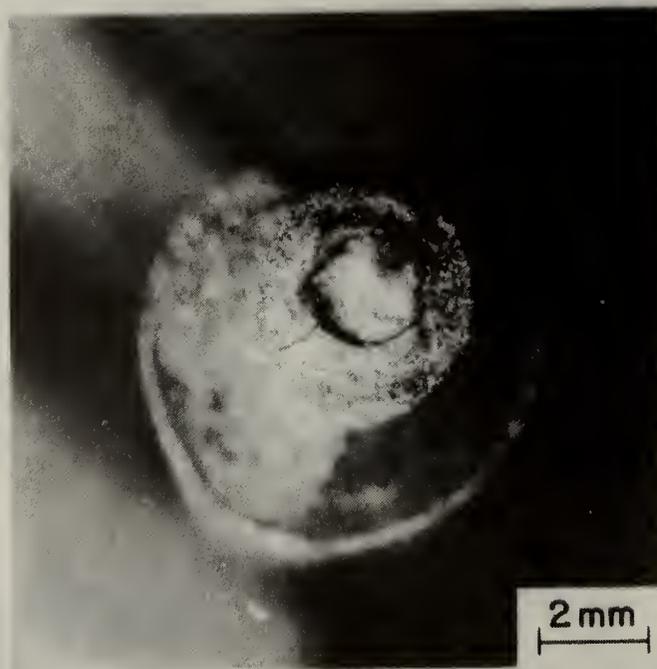
Fig. 46. In 800 specimen tested at 540 °C in wet H₂S at strain rate of 1.7×10^{-7} /s showing large amount of surface scale and remaining metal.

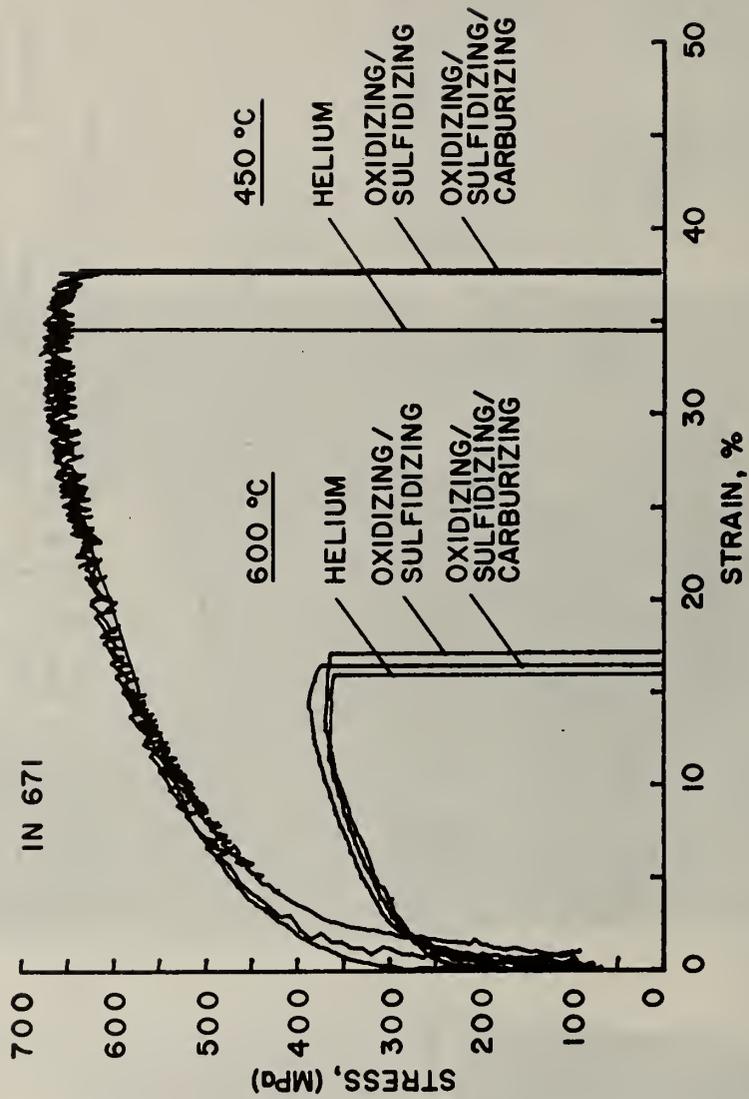
Fig. 54. Stress-strain curves for Inconel 671 tested at 450 °C (840 °F) and 600 °C (1100 °F) in He and in oxidizing/sulfidizing and oxidizing/sulfidizing/carburizing coal gasification environments at a strain rate of 1×10^{-6} /s.

Inconel 617: This alloy was tested since it has found some use as a weld overlay in coal gasification pilot plants. Tests were confined to 450°C(840°F) and 600°C(1100°F) in the simulated coal gasification environments and ultra-pure He, using a strain rate of 10⁻⁶/s. The stress-strain curves were almost coincident for all three environments at each temperature, Fig. 54. However, shallow secondary cracks were visible near the primary fractures in both coal gasification atmospheres at 450°C(840°F), but not in the case of He, Figs. 55-57. The primary fractures were ductile in character in each case, but involved less necking than in other alloys tested; this is evident from the relatively low values of RA, Figs. 55-57. At 600°C(1100°F), the strengths and ductilities were considerably reduced, Fig. 54, and this was associated with the presence of α -chromium in each case, Figs. 58(c), 59(c) and 60(c). Studies of sections of the fractured specimens indicated that numerous secondary cracks, many of which were internal, occurred within the α -chromium or at the interface between this phase and the matrix. The amount of α -chromium was found to decrease with increasing distance from the primary fracture, Fig. 61, and thus it seems that the formation of this phase is assisted by strain. It is concluded that the poor mechanical properties of the alloy at 600°C(1100°F) are due to the presence of the α -chromium phase, which was both temperature- and strain-induced. Because of the internal nature of the cracking in many instances, it appears unlikely that the presence of the environments had any influence on the formation or fracture of this embrittling phase.

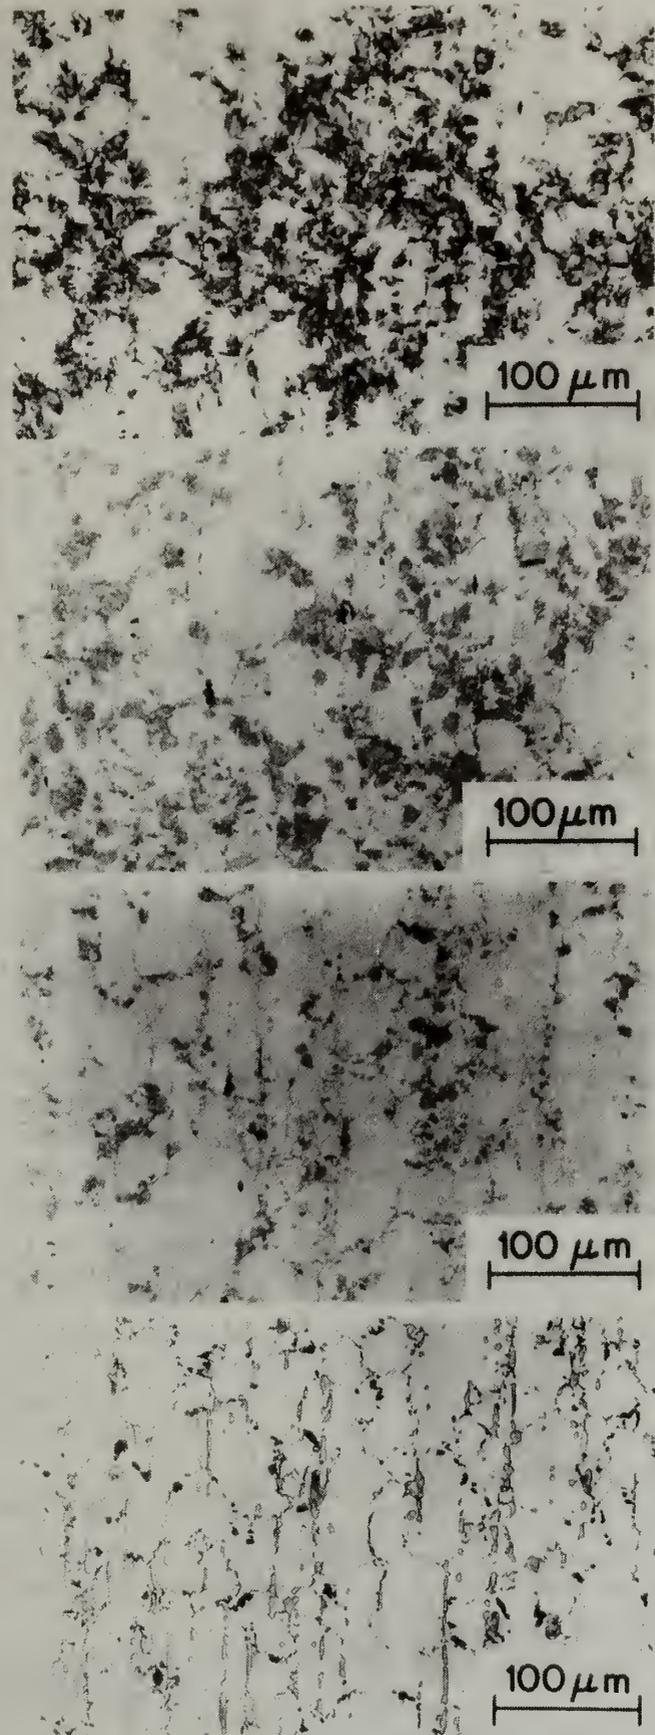
Fig. 61. Inconel 671 tested at 600 °C in oxidizing/sulfidizing/carburizing environment at 1×10^{-6} /s. (Top to Bottom) Alpha-chromium phase present in alloy due to combined effects of temperature and strain. Progressing from maximum strain (fracture surface) to a smaller strain (near shoulder area of reduced section). 200 \times .
